Manhole Inspection Summary

Manhole # S03QQ1029MH

Insp Date: **9/22/06 8:51 AM**

Location Address: **5507 JONQUIL AVE**

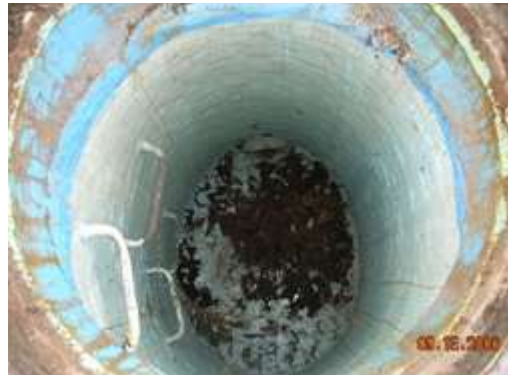
Top View

☒ **Leaks**

Infiltration: ☐ None ☒ **Joint** ☐ Cracks ☐ Mortar ☐ Roots ☐ Wall

☒ **Debris** (not Condition related)

Frame leaks. Adjustment infiltration.
Channel debris.

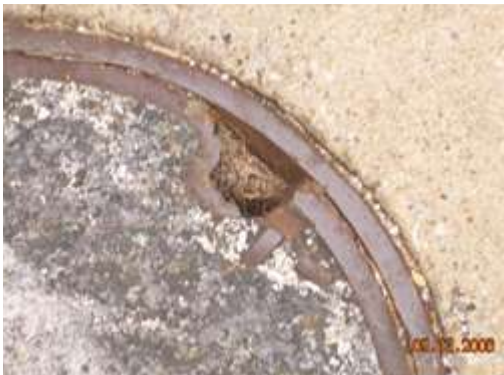
Defect

Condition: **Broken**

Broken MH cover.

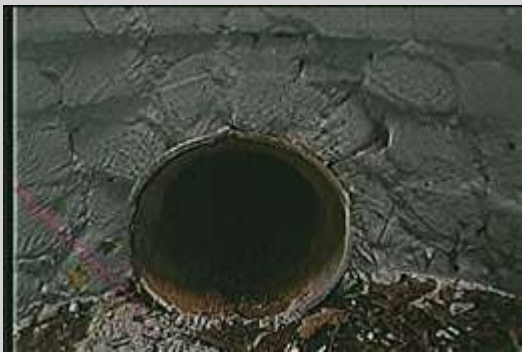
8 in. Circular Gravity Sewer
Pipe Out @ 12 O'Clock

Comments **The coating is thin enough to tell that the MH is brick. The O12 pipe picture shows that the coating has some deterioration or that it was not applied throughout with consistant thickness.**
